GUIDELINES FOR REPAIR AND MAINTENANCE OF BRIDGE COATINGS: OVERCOATING

Guidelines for Repair and Maintenance of Bridge Coatings: Overcoating

PUBLICATION NO. FHWA-RD-87-092

AUGUST 1997

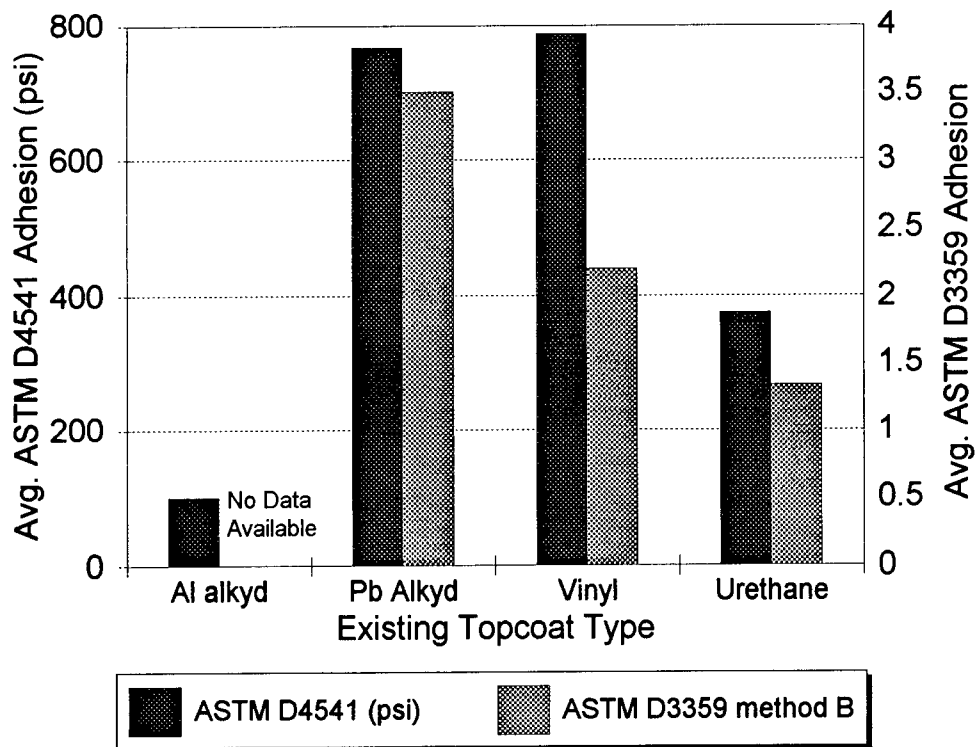
Figure 5. Initial adhesion results for the cyclic accelerated test panels.

The adhesion data presented in figure 5 provides some insight into the relationship between adhesion as measured using current ASTM test methods, and the potential for disbondment and peeling of the existing coating by the applied overcoat. This mode of failure has been seen in the field, in some cases after only short periods after overcoating application. Field measurement of adhesion has been proposed as a method for determining the "acceptability" of an existing paint system for overcoating; however, no standard value of adhesion has been sufficiently identified. The test panels used in this program had adhesion ranging from zero to 5,500 kPa (800 lbf/in²), even over the limited surface area of the relatively small test panels. Following surface preparation, only the areas with adhesion on the order of 1,400 kPa (200 lbf/in² as indicated in figure 5) remained on the panels. Since no gross disbondment of the paint systems was seen during the testing, it is reasonable to conclude that the coating remaining on the panels after surface preparation had adequate adhesion to accept the various overcoating systems. It is also reasonable to assume that a less aggressive surface preparation may have left more existing coating with potentially lower adhesion on the panels, which may have produced different results with respect to disbondment of the remaining paint systems after overcoat application.

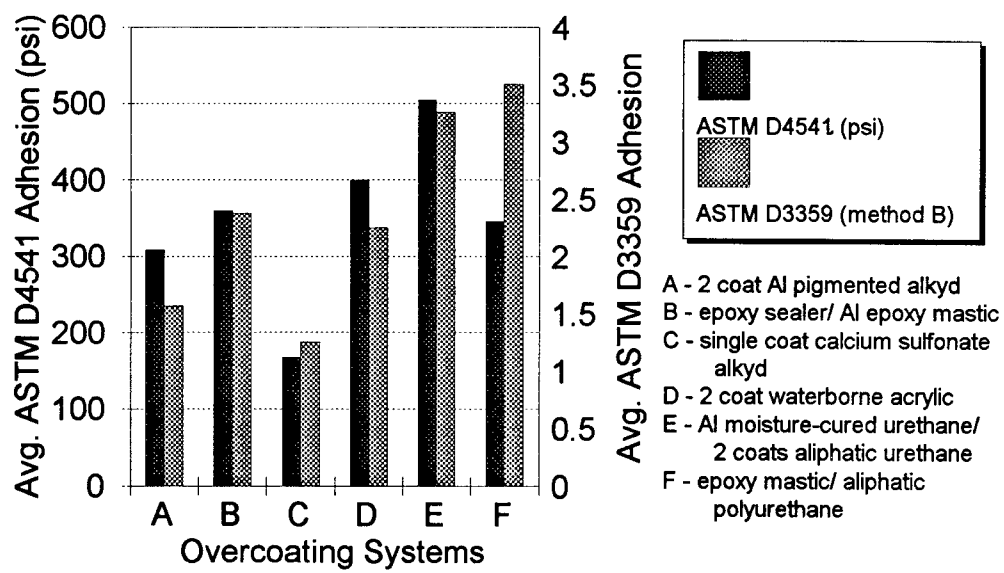
Figure 11. Adhesion testing results following the cyclic accelerated test.

Figure 11 shows the results of adhesion testing following the cyclic accelerated test. With the exception of the calcium sulfonate alkyd, all of the overcoating systems adhered sufficiently to the existing topcoats to cause adhesion failure within the layers of the existing substrate coating. This means that the older coatings were the "weak link" in the composite coating system in terms of mechanical adhesion. The lesser physical properties of the calcium sulfonate alkyd system attributed to the poor mechanical adhesion results for that system. An important observation from figure 11 is the general correlation between the cross cut and pull off type adhesion tests. With the exception of system F, the relative results from system to system for these two adhesion test methods show that either method may be sufficient to compare the mechanical adhesion of different maintenance overcoating systems.

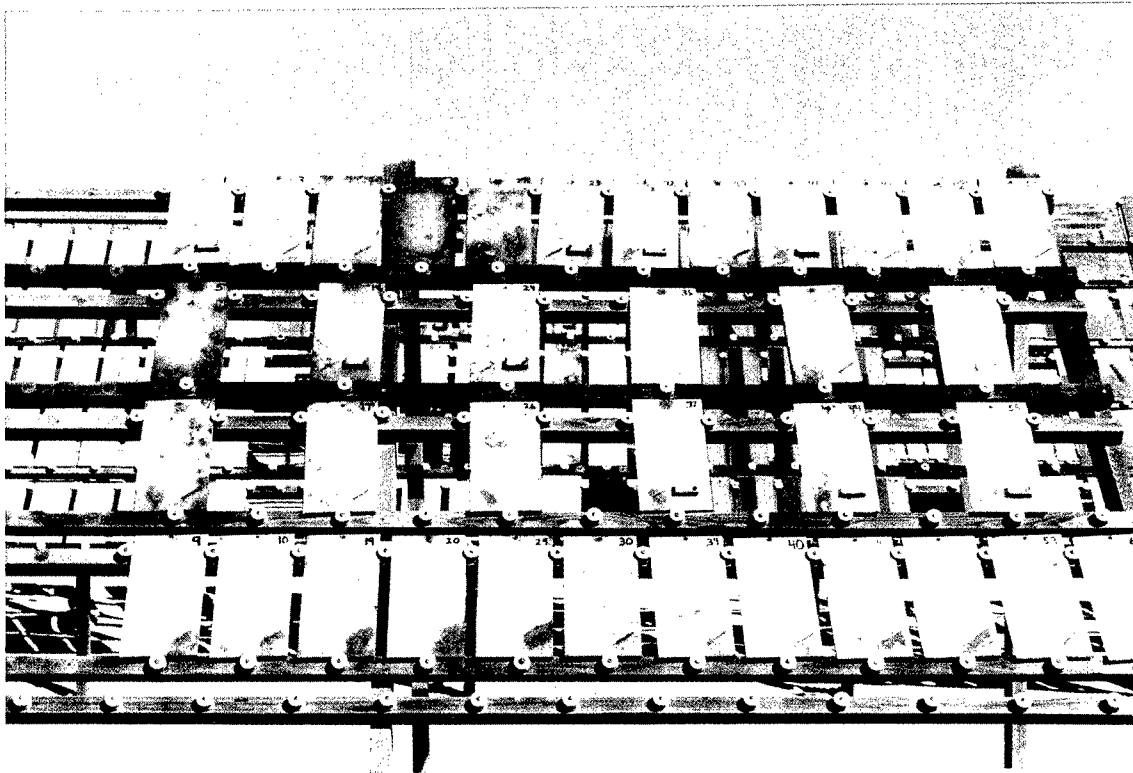
Figure 12. Overcoating test panels exposed at the marine exposure location.

Figure 12 shows a photograph of the panels exposed at the marine exposure location. Figure 13 is a diagram identifying the steel condition, coating system, and overcoating system history of each panel. The panels are arranged according to the overcoating systems (columns) and the original type of topcoat (rows). The figures have panels missing in some places because every possible scenario could not be evaluated due to the limited number of panels available from the previous FHWA project. By observing the conditions of the panels in figure 12, and knowing the condition history of the surfaces painted through figure 13, one can see that several factors affect the performance of the coatings.

The most important observation from the photograph of figure 12 is the relation of the original panel condition at the time of overcoating to the current condition of the panel. The panels that are showing the most degradation were originally prepared using a hand-tool cleaned substrate (7 years ago), then allowed to degrade, then prepared and overcoated. For the most part, panels that originally began with an abrasive blasted (near white) surface are in the best condition. These abrasive blasted panels were in better condition (compared to originally hand tool cleaned panels) at the time of overcoating. These results imply that not only the surface preparation must be considered when estimating the performance of a particular overcoating system, but also the history of the surface being overcoated, and the corrosion condition of the surface at the time of overcoating.

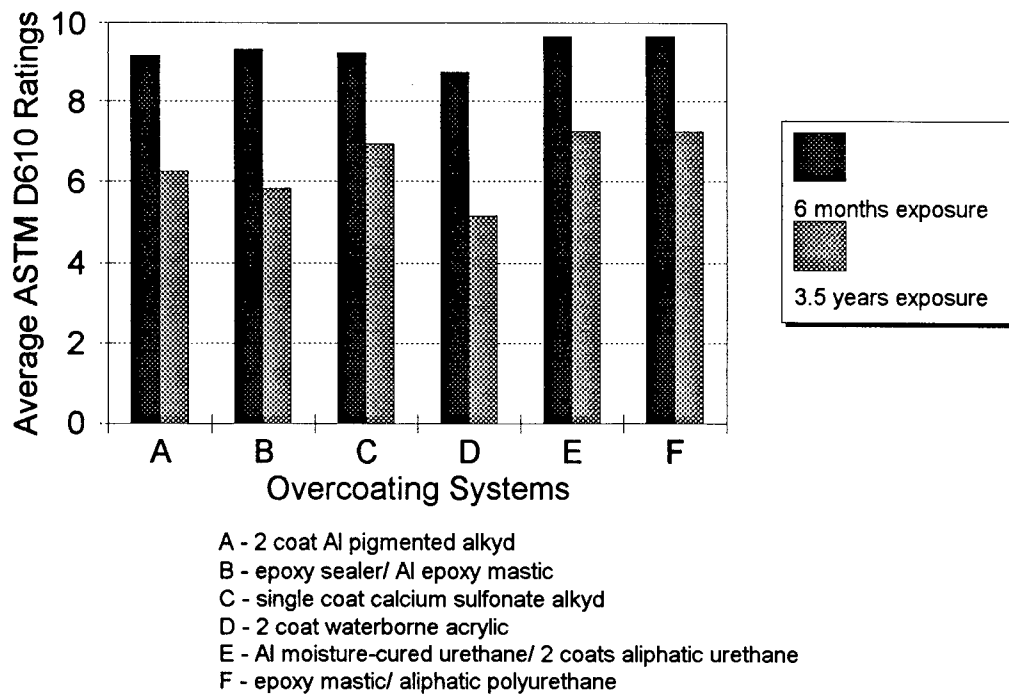
Figure 14. Visual rust ratings for the overcoating systems exposed in the marine environment.

Figure 14 shows the ASTM D610 visual rusting ratings for the six overcoating systems exposed in the marine environment. Relative results between the six overcoating systems in figure 14 are similar to the relative results of the cyclic accelerated test shown in figure 6. An important observation from figure 14 is that only a short exposure time was necessary in the accelerated natural marine environment to distinguish the relative performance between the coating systems. The results after 6 months from system to system are similar to the results between the systems following 3.5 years of exposure. This may signify that a relatively short duration "patch test" can provide reliable information regarding longer term overcoating performance.

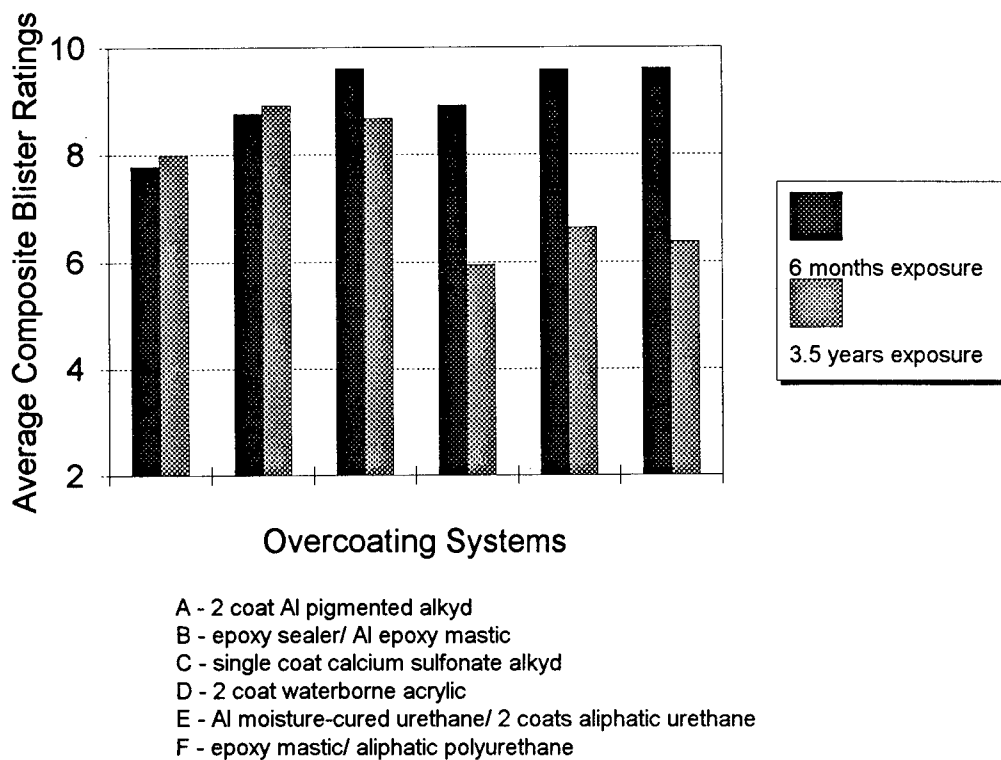
Figure 15. Composite blister ratings for panels exposed in the marine environment.

Figure 15 shows the composite blister ratings for the exposure panels. The visual blistering data does not show the same time/degradation trend seen with the visual rusting data of the same panels. The blistering of systems A and B has not advanced compared to what was observed after the first 6 months of exposure. The short time to initial blistering displayed in figure 15 indicates that coating over existing surfaces in a highly corrosive, salt-rich environment may show different blister performance in a relatively short time period. However, all of the blister results displayed in figure 15 (following marine exposure) are less severe than the blister results of the cyclic accelerated test (figure 7).

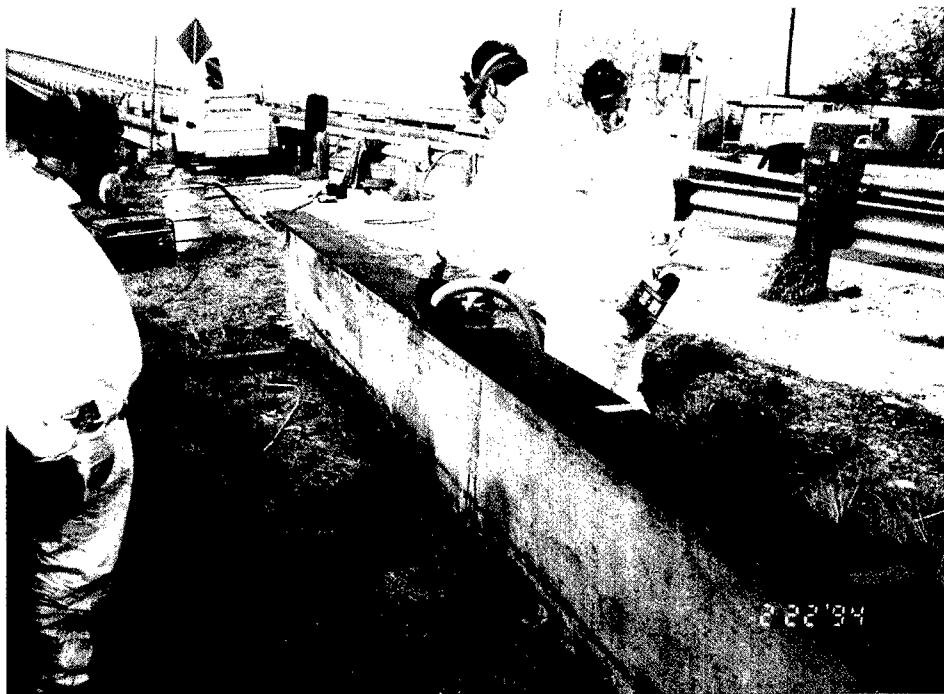
Figure 28. Surface preparation on test beams.

Figure 28 shows a worker performing surface preparation on one of the relocated beams referenced in figure 25. The monitoring data presented earlier in this discussion was obtained during these activities. The initial condition of the two test beams can be seen in figure 28. The coating system was damaged and the steel was corroding over much of the beams.

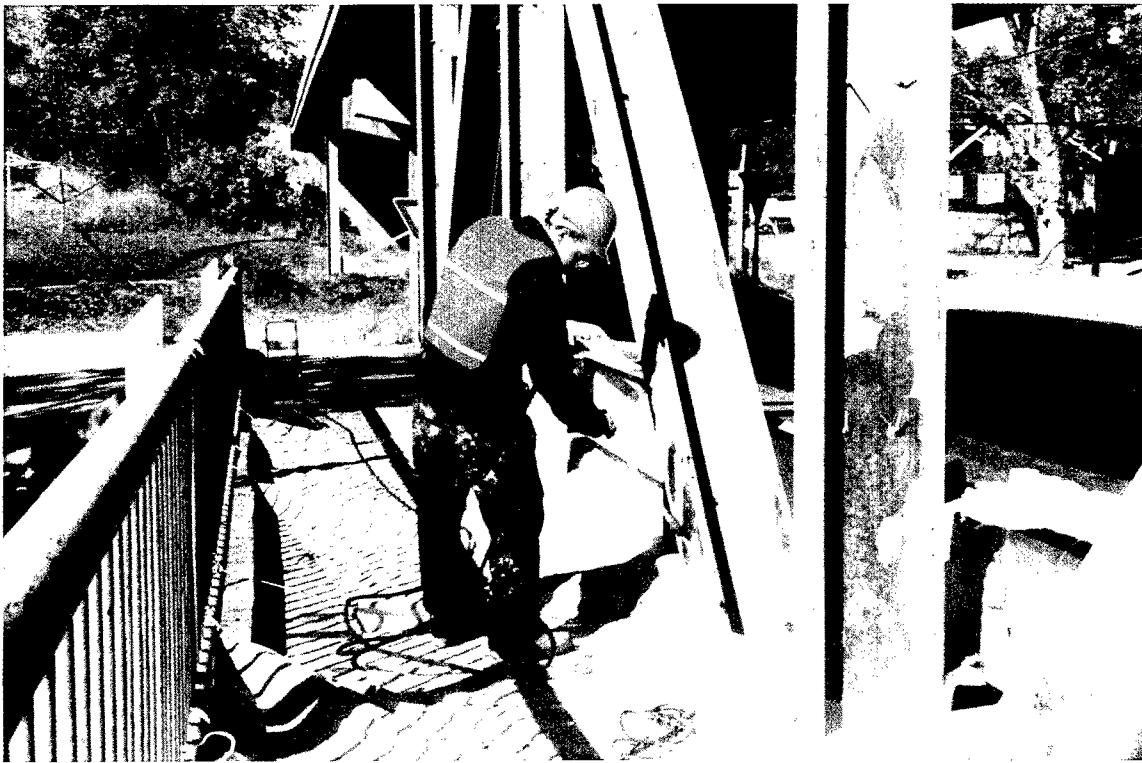
Figure 30. Pressure wash of existing coating system at New Hampshire Bridge.

Figure 30 shows the pressure wash surface preparation on the truss members of the bridge. Before surface preparation, the coating system in this area was peeling to the red-lead primer or slightly corroded millscale. The extent of the peeling was not as significant as that shown in figure 30 as much of the marginally adherent coating was removed with the pressure wash. The overcoating systems on these bridge members have not shown much corrosion to date. The corrosion present is located on areas where the existing coating system was removed to bare steel and on the edges of the truss members. The areas where the existing coating was overcoated with the test systems show zero corrosion and minimal peeling.

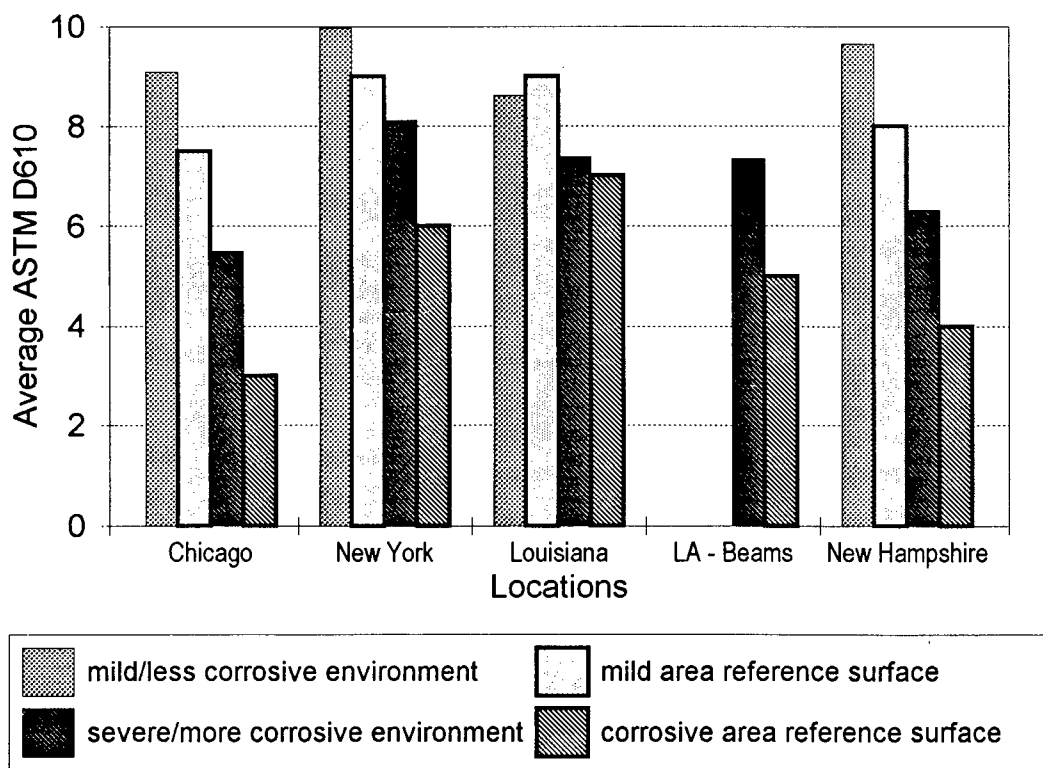
Figure 33. Overcoating performance comparison by micro-environment and site location.

Figure 33 shows a comparison of the average inspection data from the location of each set of test patches. The figure shows averages of all coating systems tested at the particular location and also shows the reference condition of similar areas of the structures not overcoated. In all cases, the areas classified as "more corrosive" on the bridges have resulted in more numerous areas of corrosion upon inspection of the test patches (third bar is lower than first bar).

The results presented in tables 5 through 8 and figure 33 clearly show that the initial corrosion condition of a structure will influence the performance of an overcoating system. Without exception, all of the more corroded expansion joint areas that were painted resulted in more coating breakdown than the fascia girders or truss members on the same bridge painted with the same coating systems. The power tools used were not effective at removing the tightly adherent rust that had advanced to SSPC initial surface condition D. The coatings applied over the remaining rust were prone to early (within a year) rust through on most edges and difficult-to-clean areas.

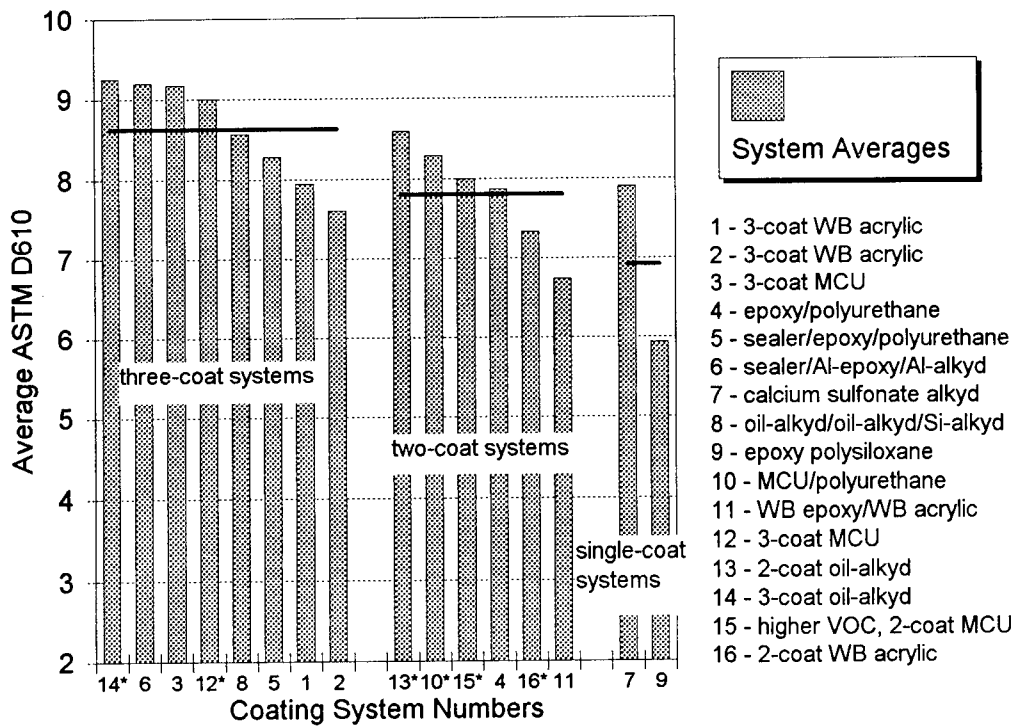
Figure 34. Comparison of the number of coats applied to the final rust ratings for all overcoating systems.

Figure 34 shows that less rusting was observed for overcoating systems that were comprised of three coats of paint. The data presented is from all exposure locations and includes all systems tested. Those systems not tested at all four sites are shown with an asterisk. The multi-coat systems apparently covered the substrate better because of repeated applications. The single coat systems had a tendency to pin point rust after some exposure time, evidence of weak areas or holidays in the applied film.

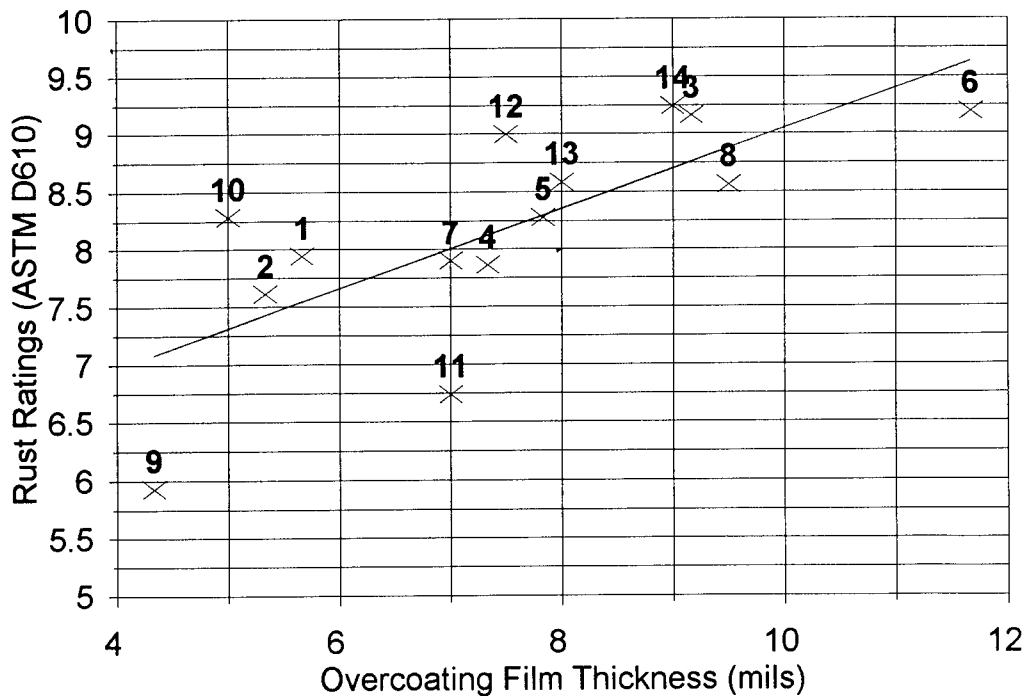
Figure 35. Comparison of overcoating system DFT versus average rust ratings.

Correlation of the overcoating system DFT to exposure performance for the field systems was constructed using the Tooke readings obtained during the study. Figure 35 shows the results of this correlation and indicates that thickness of the overcoating system was very influential to system performance. The figure shows coating system thickness along the X-axis plotted against the average rust ratings on the Y-axis. The individual system averages are shown with a linear

Caution should be taken as to the extension of this observation. The rusting failure was almost exclusively limited to areas where the existing bridge coating was removed during surface preparation. Figure 35 shows that thicker films performed better at these areas. An "overly thick" overcoat may add a large amount of stress and weight to the composite coating system. This forms a basis for recommending spot primers for production scale overcoating work.

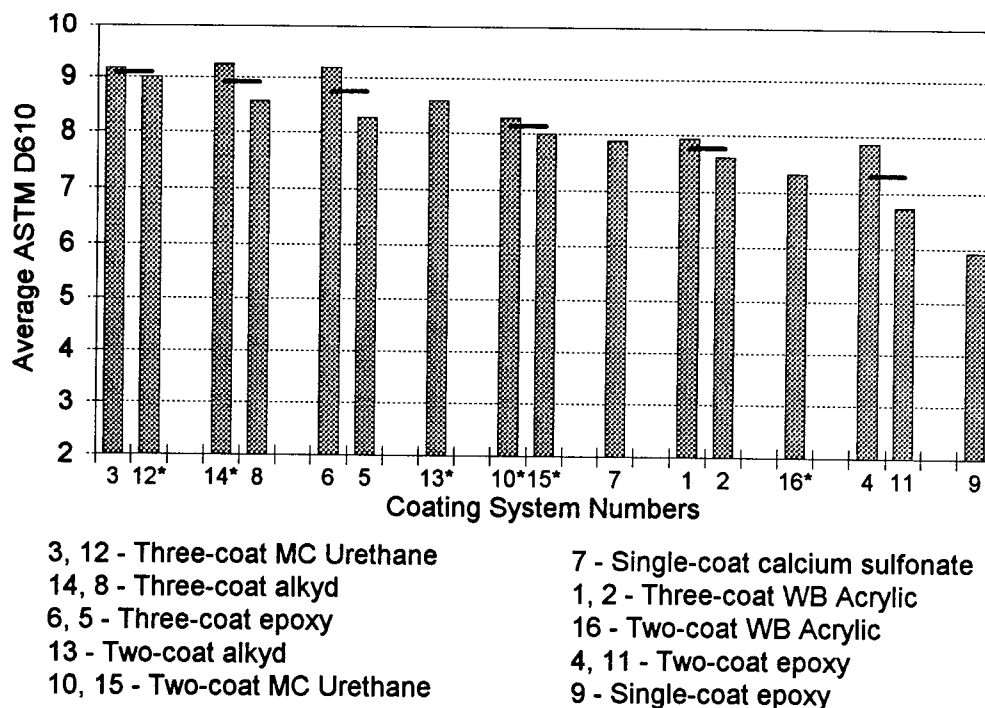
Figure 36. Comparison of the generic overcoating type to rusting performance for all overcoating systems.

Figure 36 shows the performance of the overcoating systems based on the generic resin type of the coating (or primer coating for multi-coat systems) and the number of coats in the system. This plot is particularly useful because it shows the average performance of each individual coating system. Those coating systems not tested at four sites are shown with an asterisk. This data shows that better performance was obtained with moisture-cured polyurethane or alkyd resin based systems applied in three coats. This result is in agreement with the thickness dependence result emphasized by the data in figure 35.
